Photos of Architectural Features:

These pictures are presented to illustrate features mentioned in the HSR and to offer a glimpse of normally inaccessible parts of the house. The unit "B" cellar is full of duct work and wiring and is totally unlit.

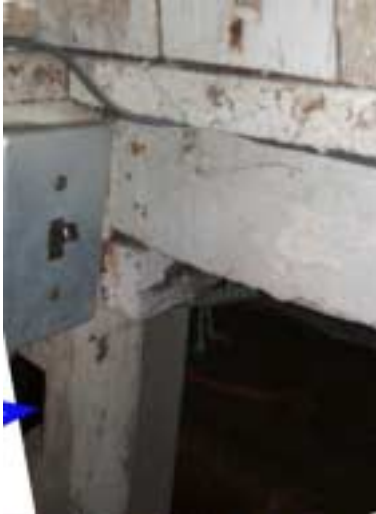
Left Photo: White wash stair wall and remaining white-washed, notched post.

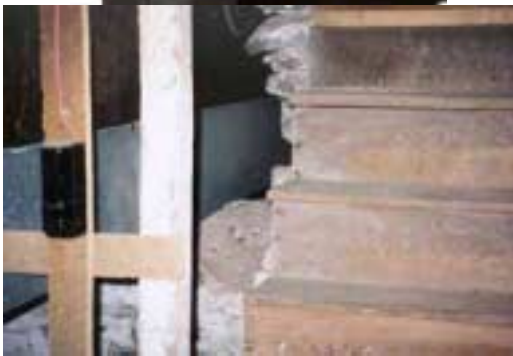
Present straight-run stairs from unit "B1" to "A0" (cellar) are to SOUTH of white-washed post.

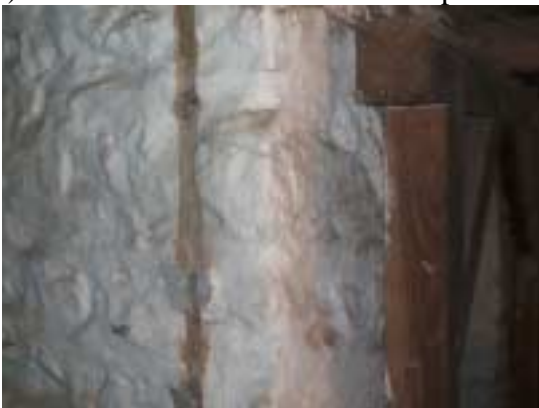
Much less white-wash in vertical groove, where board boxing in "A1"- "A0" stair once fit. Stairs would run from next to "A1" east fireplace and wrapped around to enter "A0" cellar to NORTH of post, under & parallel with "A1"- "A2" winder stairs.

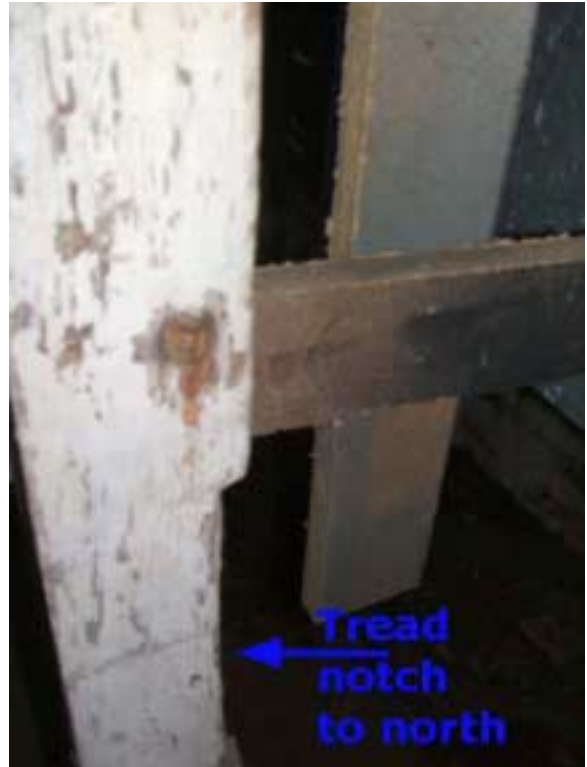
Blue arrows shows notches in white-washed post where treads of old stairs fit in different orientation.

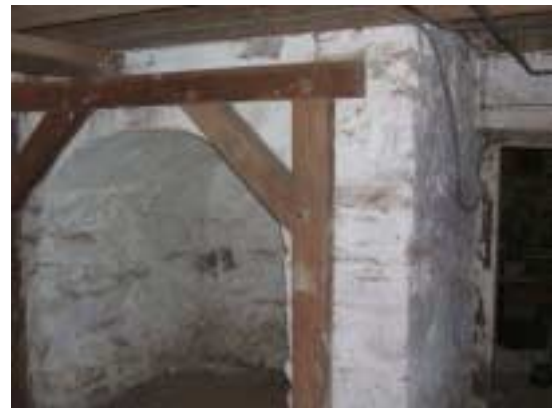
East fireplace breast showing wooden structure supporting embedded beam supporting unit A 1st floor joists. Opening to the right (south) leads to Unit "B" cellar.

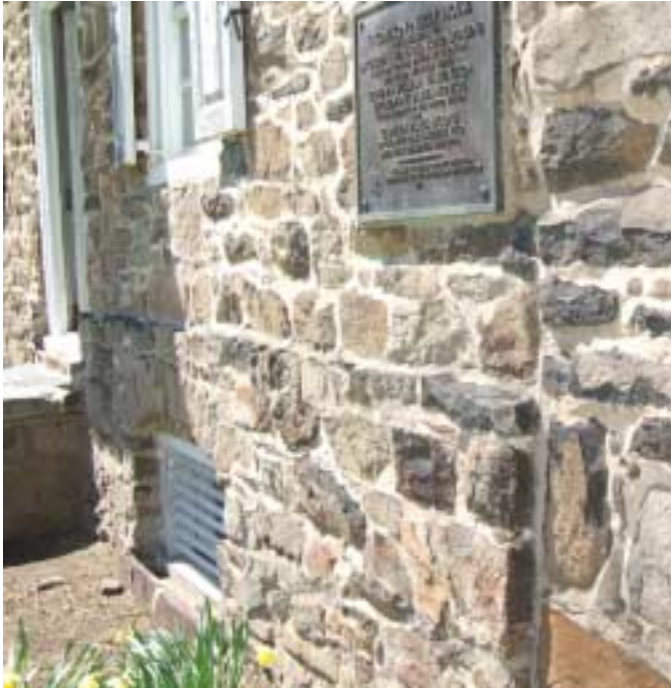
South exterior of unit "A". water table protrudes horizontally midway between cellar and 1st floor windows. It is noticeable in jagged shadow and shadowed edge at "A" – "B" vertical mortar seam

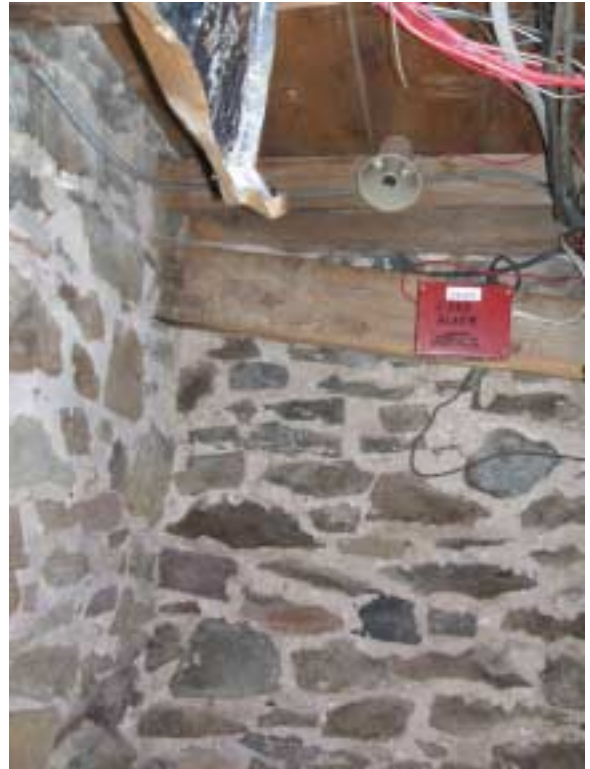
Current floor joist above old, sagging floor joist along east end of "B0" cellar. North end of old joist embedded in "B0" fireplace mound.

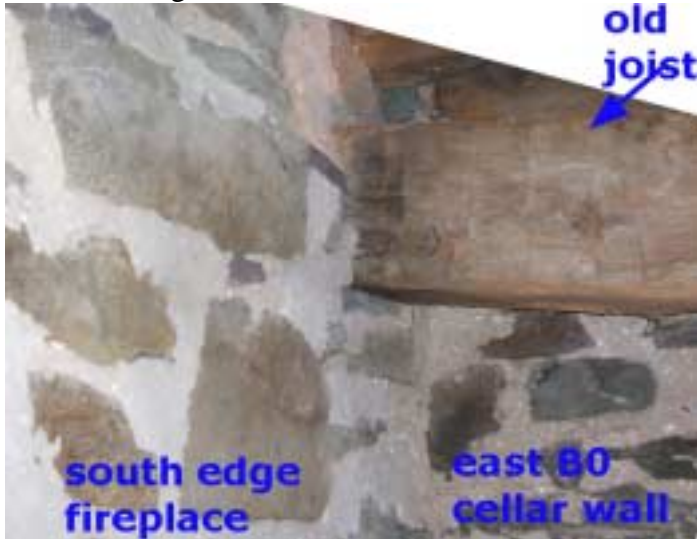
Close-up of old floor joist along east wall of "B0" embedded in south end of fireplace mass. Current floor joist directly above it.

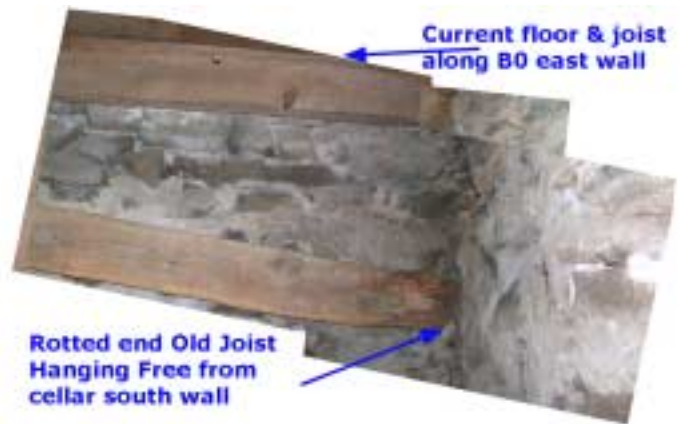
Close-up of rotted south end of old floor joist now disconnected from south "B0" cellar foundation and dangling free.

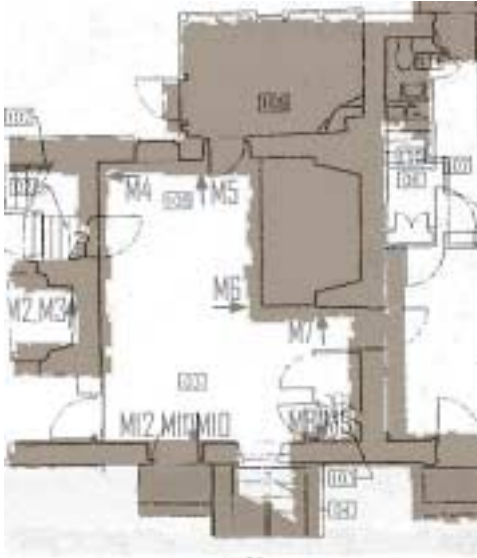
Unit "B" cellar (brown) with black outline overlay of 1st floor. Cellar Mortar sample locations marked. Old retaining wall along east end of "B" visible in this diagram and as N-S running ledge in "C0" kitchen.

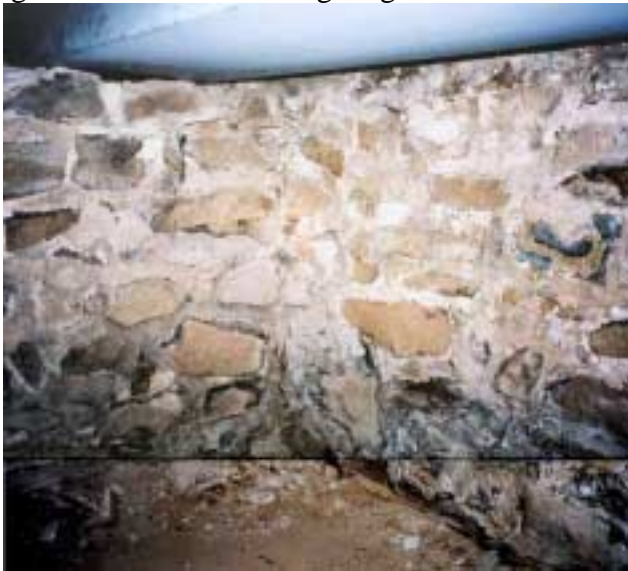
Unit "B" N-W cellar corner. Duct runs over west wall & parallel to north wall.

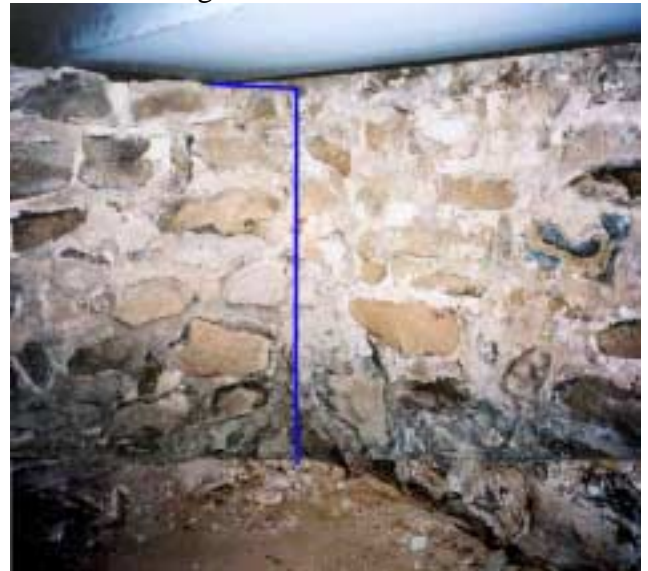
Blue line shows top and north end of west wall as it abuts north wall. North wall existed when west wall built.

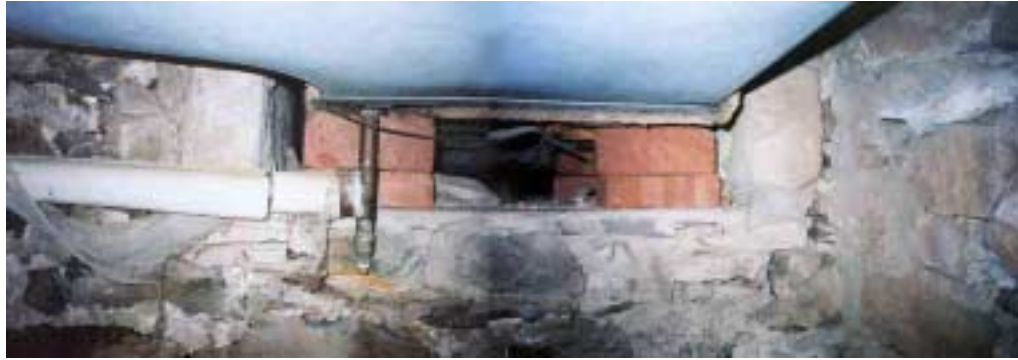
Opening in north wall "B0" to shed crawl space. HSR says wood sill [at base of opening] may date to an older structure. Brumbaugh says same for lintel (obscured by ductwork). West face Fireplace mass to right.

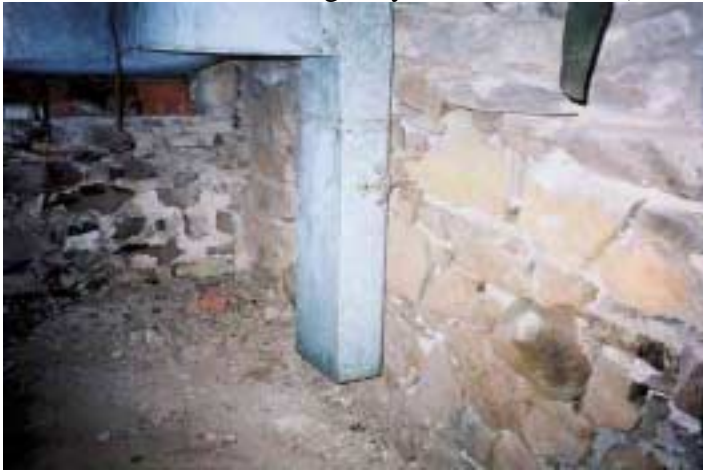
North wall & crawl-space entrance visible under duct work. Vertical duct abuts west face of "B0" fireplace mound hearth extension. Note variation in hearth extension finish.

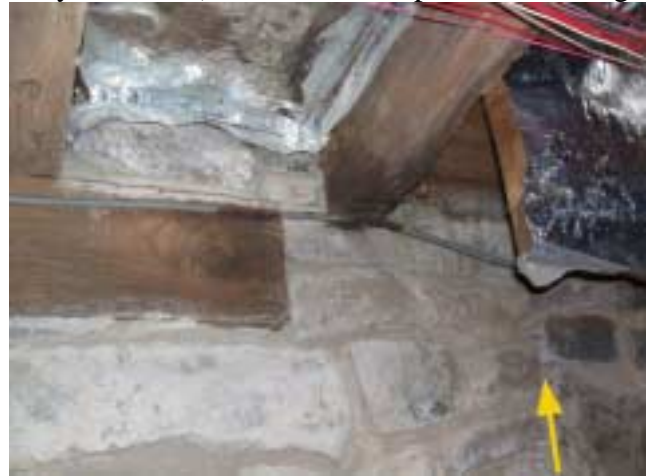
Summer beam embedded in west facing hearth extension (everything to left of yellow arrow) indicating floor was raised to new level when hearth extension added.

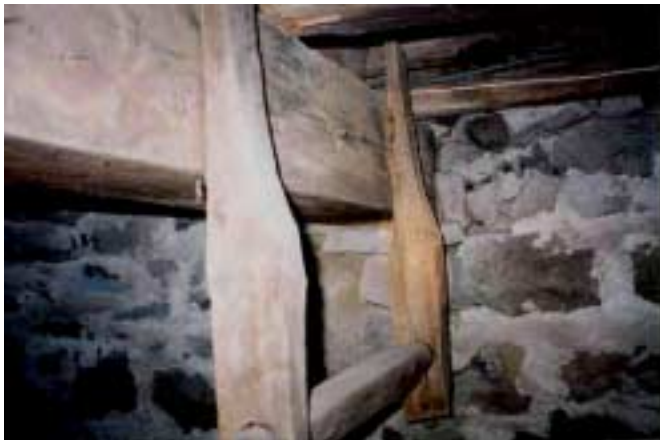
Storage rack hanging from central East-West summer beam under 1st floor joists in "B0" cellar. West end of beam rests in large pocket on west wall. (Other end is embedded in fireplace mass.)

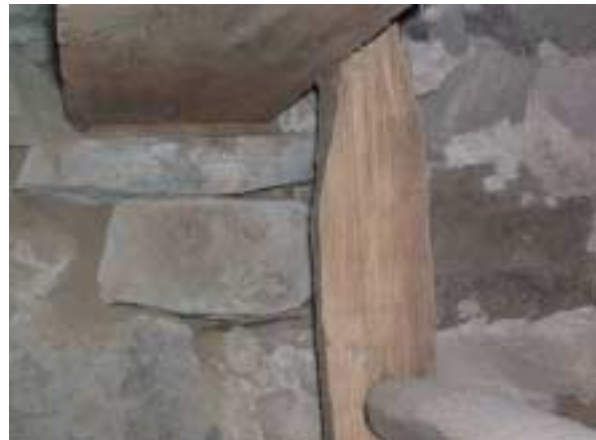
West end of summer beam rests on loosely piled rocks filling the pocket to bring the beam from its original position when unit "A" & this wall were built to its new position when hearth extension built..

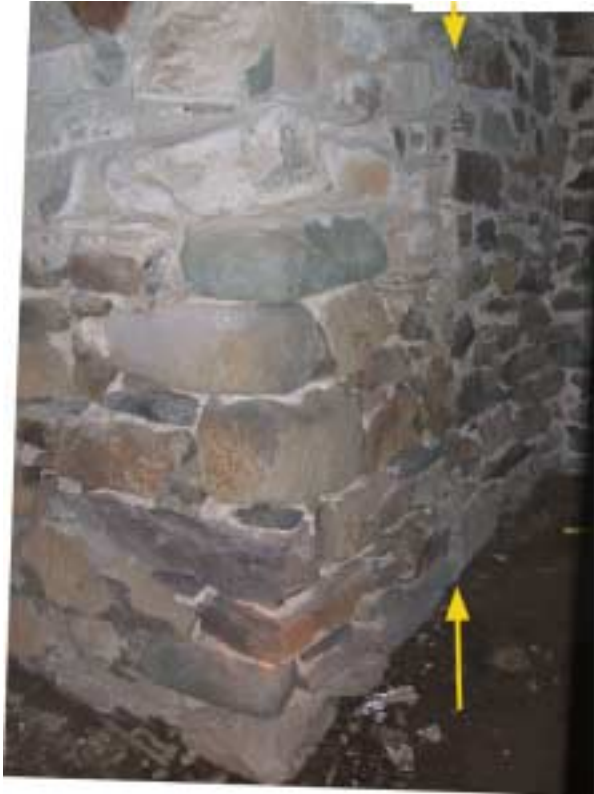
S-W "B0" corner fireplace mass- primarily hearth extension underpinning. Stones nearer floor are smaller. Yellow arrow indicates vertical groove delineating extension from original mass. East cellar wall in background.

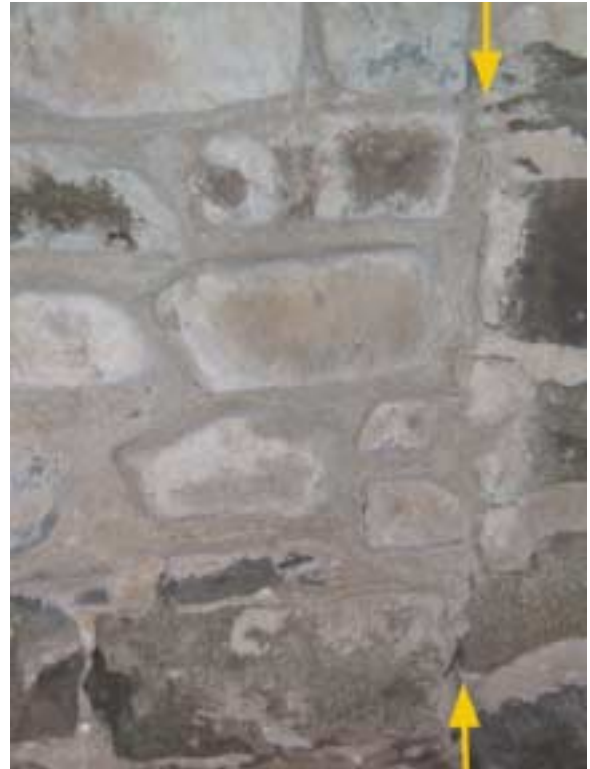
South edge of fireplace mass, showing vertical groove. Hearth extension is to the left.

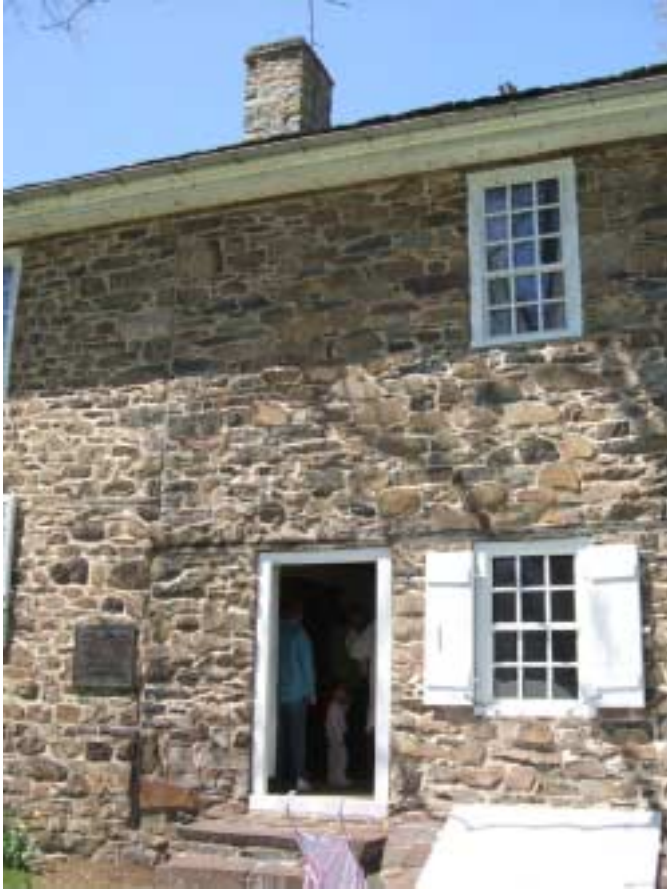
Vertical seam between units "A" and "B". Unit "A" water-table seen as shadow on "A" side of seam under plaque. Wooden beam aka "plate" just above door run length of unit "B" on south side.

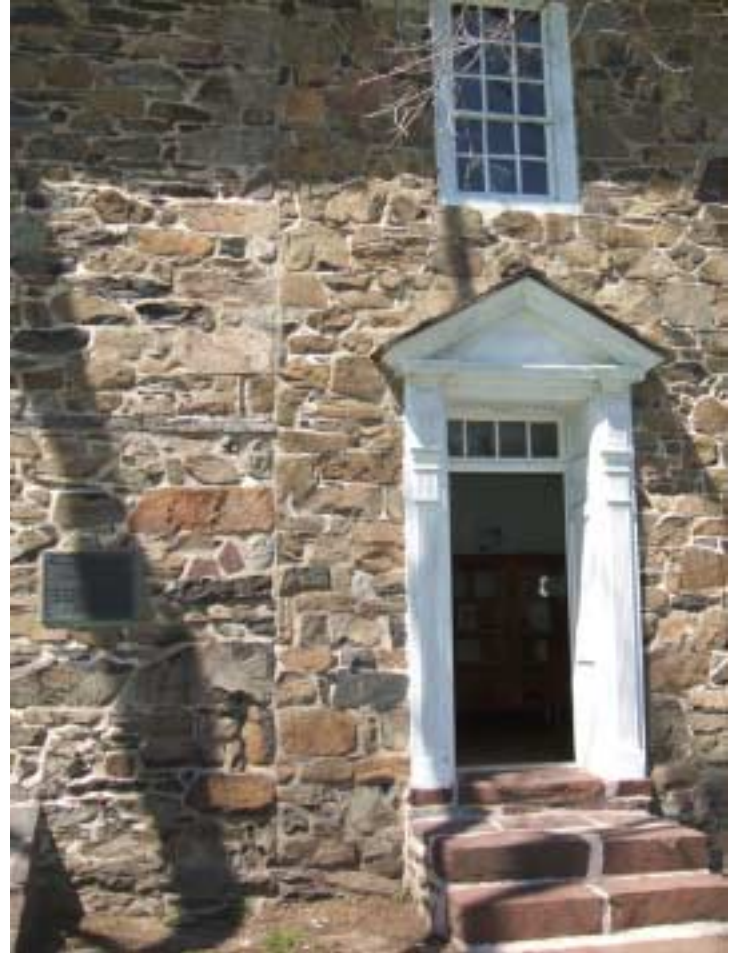
Vertical seam separating unit "B" from "C" on the right. Note large stone quoins forming SE but not SW corner of unit "B".

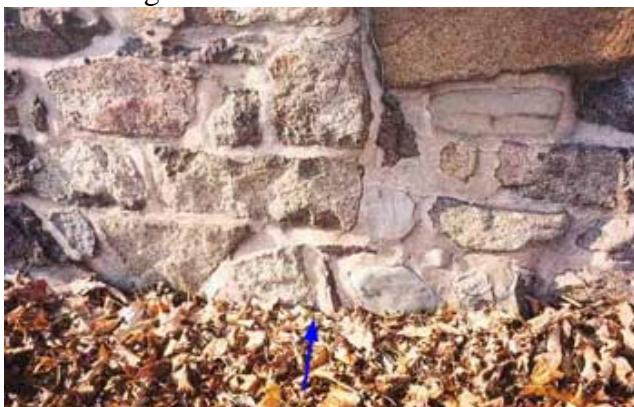
South wall Vertical seam jogs 4" to the east from unit "A", resulting in a ground-level notch.

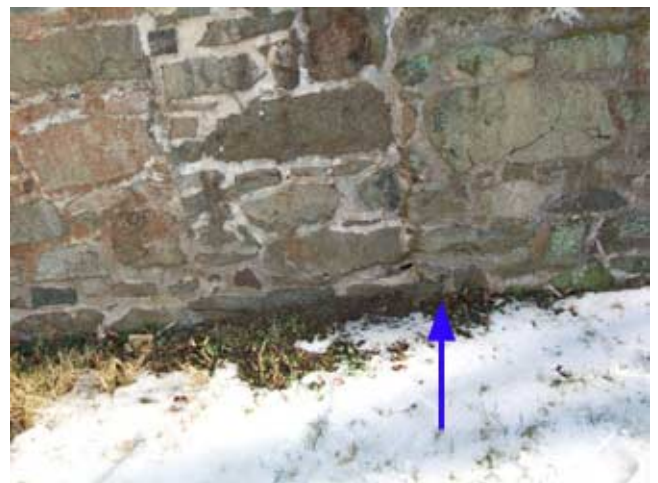
North wall Vertical seam jogs 4" to the east from unit "A", resulting in a ground-level notch

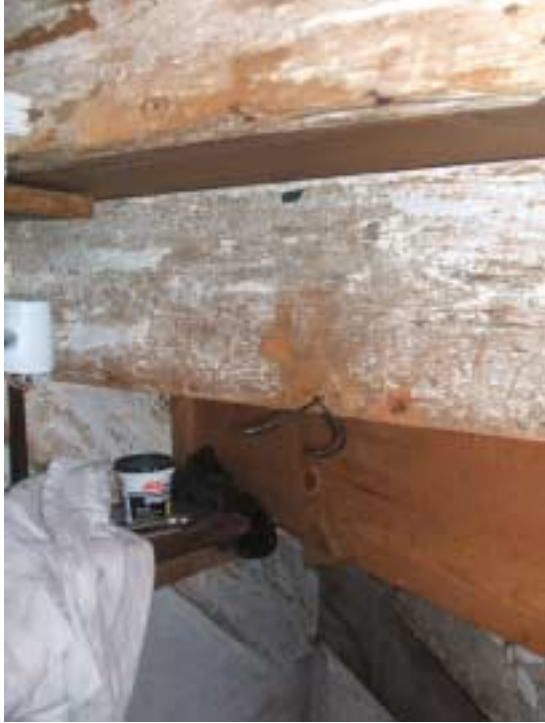
White-washed underside of stairs between 1st & 2nd floors of unit “B”, indicating there once was a parallel set of stairs underneath them leading to the south-east cellar of “B0”.

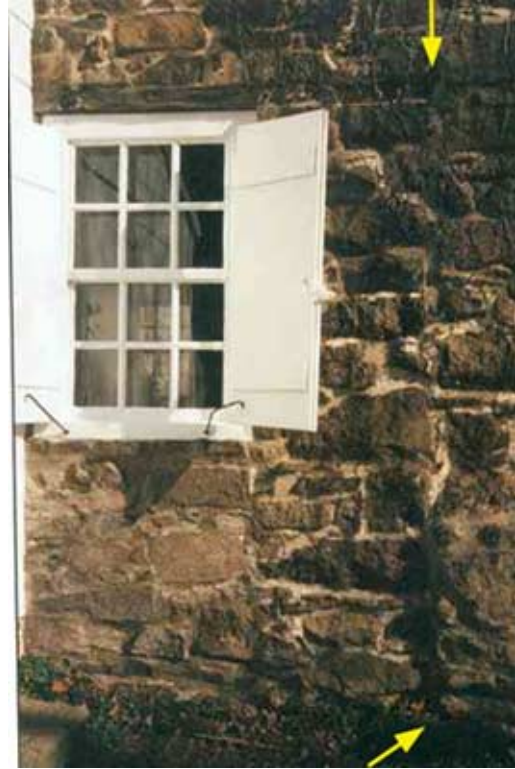
Unit “B” north exterior shows where a doorway has been filled in to hold a window. Yellow arrows indicate vertical seam with unit “A”. Note wooden “plate” over window. Lower arrow indicates location of ground-level 4” jog to the east of vertical seam.

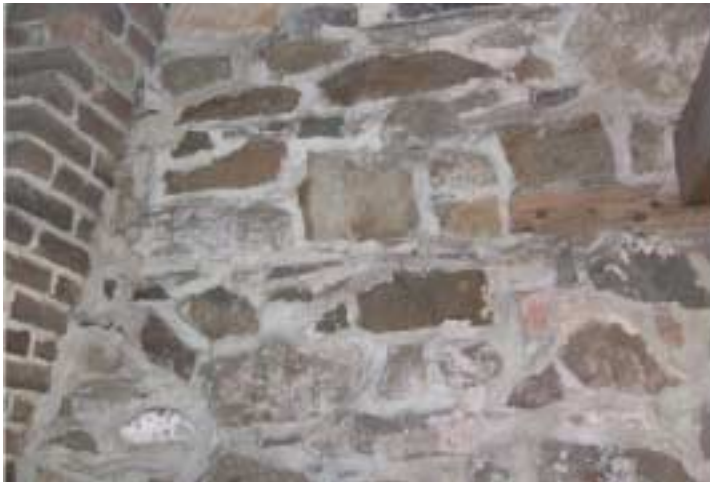
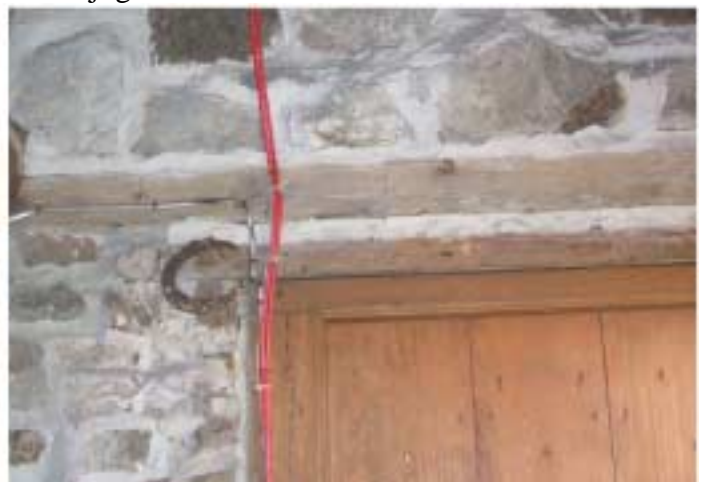
View of north plate from inside shed. Plate stops well before brick flue of beehive oven to left. Door to room “B108” is positioned just below plate.

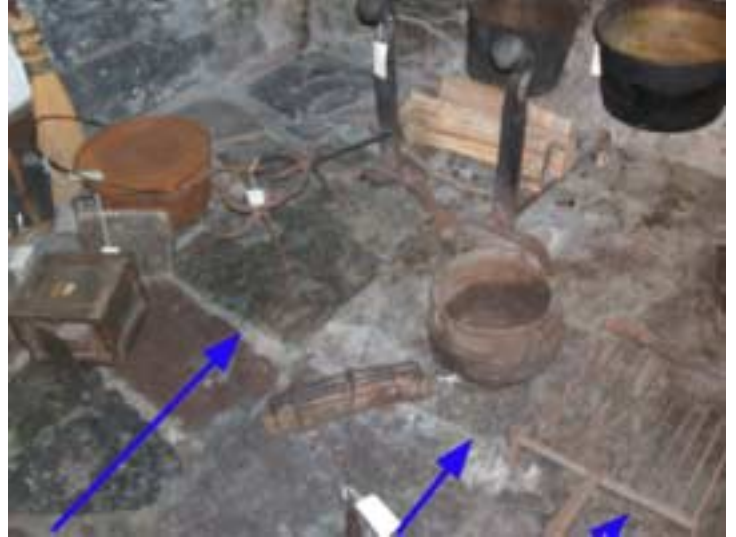
Blue arrows point to N-S seam of "B1" Hearth Extension

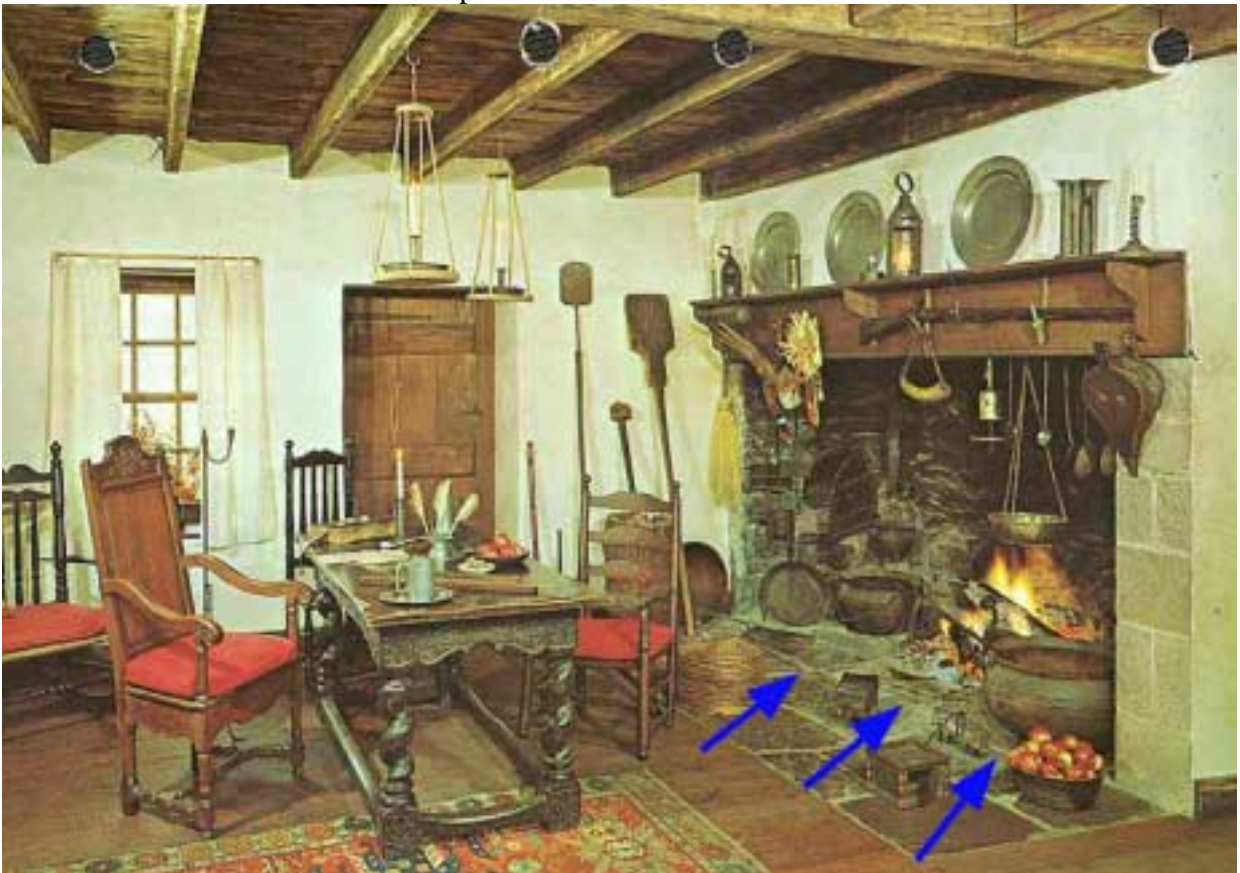
Blue arrows highlight north-south seam in hearth indicating area extending into the room is an addition.

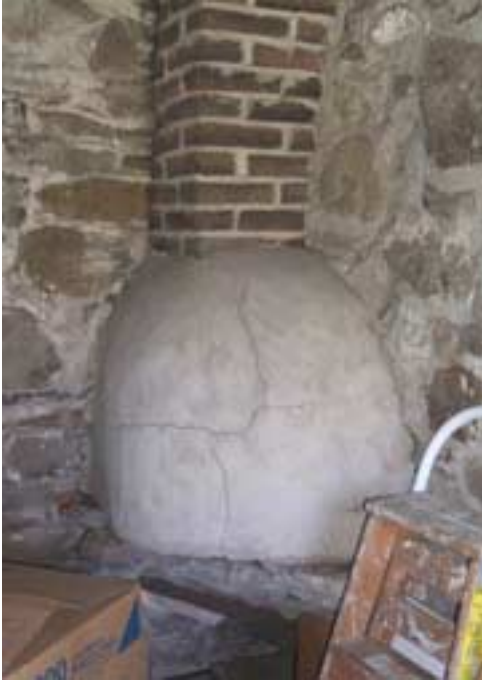
Exterior and brick flue of beehive oven

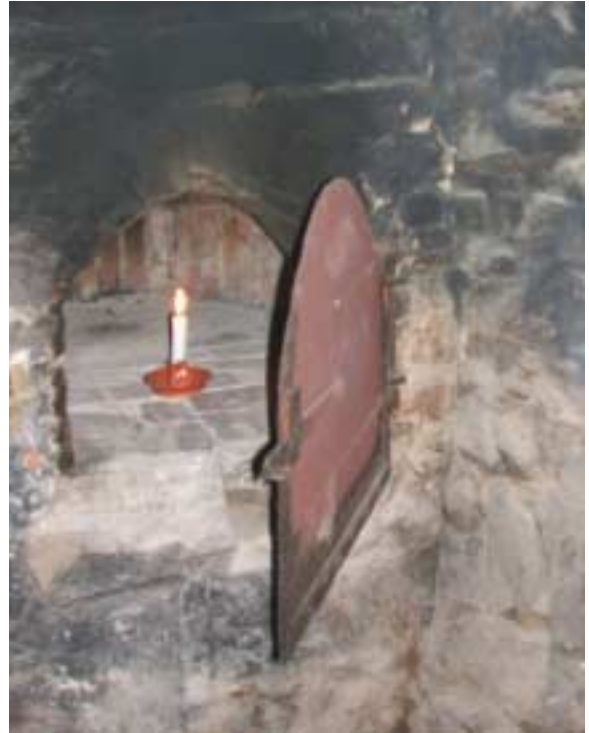
Beehive oven in north jamb of "B1" fireplace

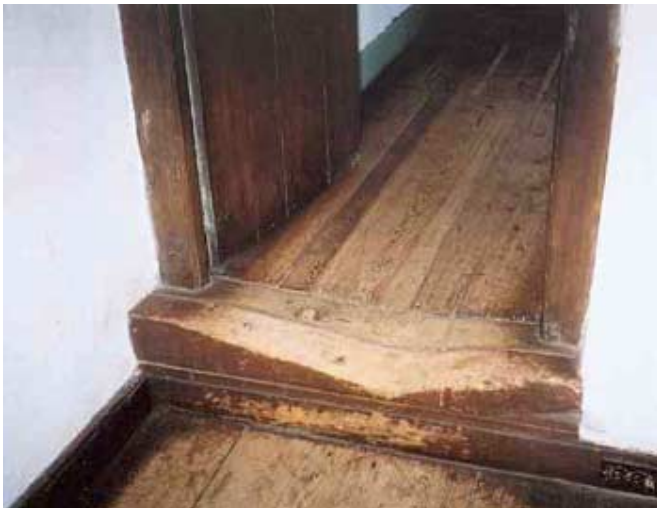
Door between units "A" and "B" is recessed in the wall, 4" to the west.

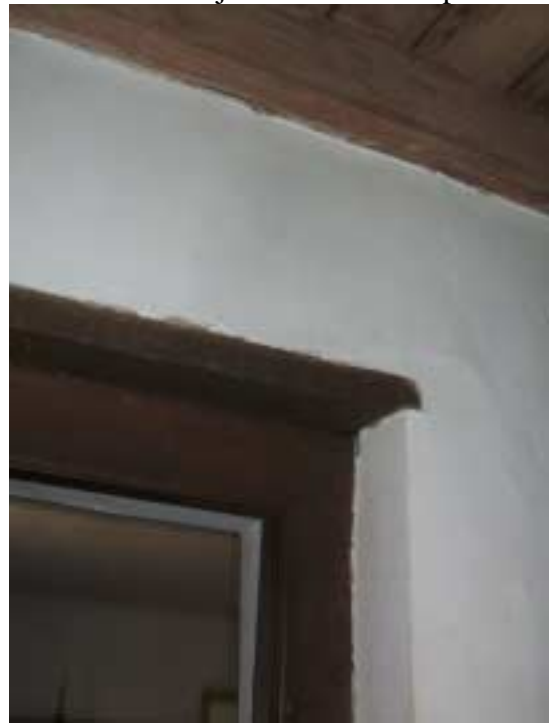
Interior door between units "A" and "B" recessed in the wall, 4" to the west.

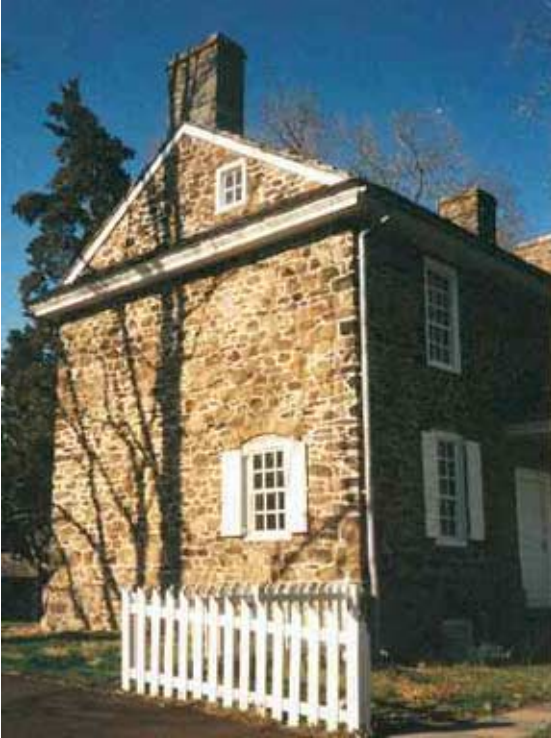
West end unit "A". Note Garret SW window, protruding ledge cornice. Once the east end of unit "A" looked like this, rotated 180° – it had a NE garret window. Note darker chimney stone.

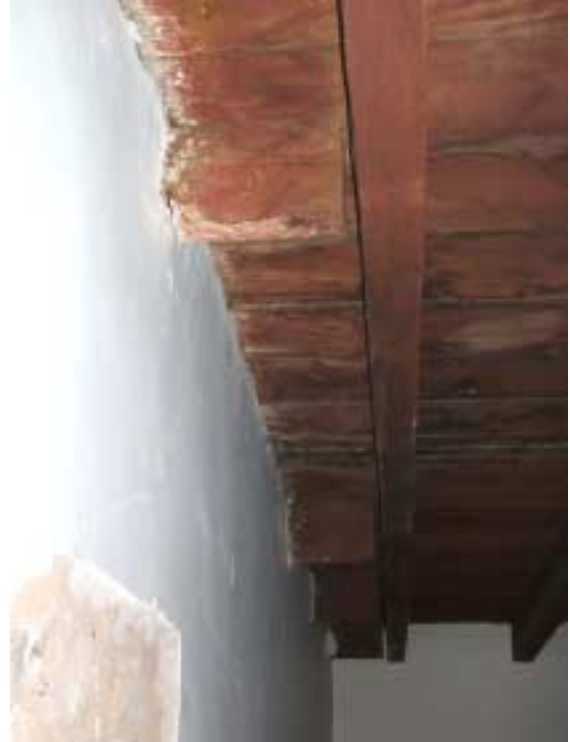
Unit "B", 2nd floor shows East cornice supports protruding from the west wall, which once was the exterior wall of unit "A". The cornice protrusions are not supporting or connected to the unit "B" garret floor joists, that make up the ceiling.

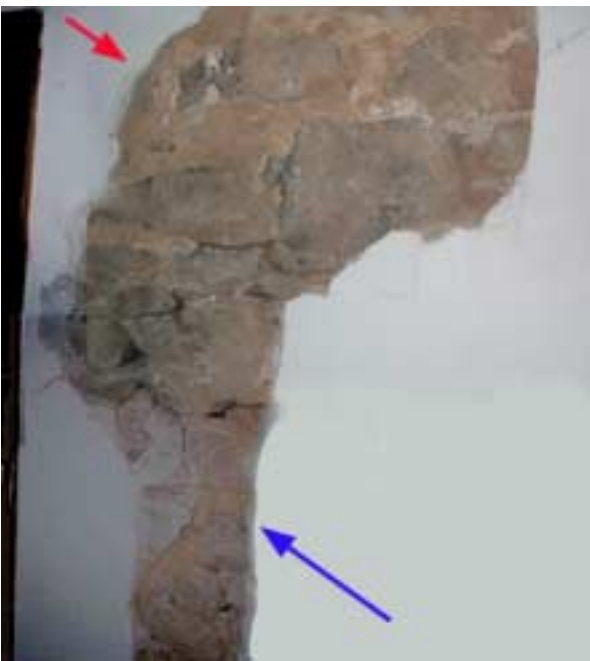
Red Arrow shows mortar with exterior finish. Blue arrow shows rough, unfinished interior garret mortar. Pencil diagonal line drawn on plaster shows the conjectured south roof slope, based on mortar.

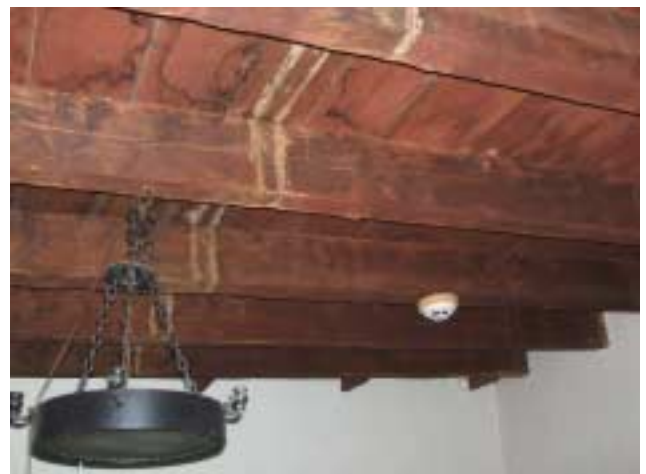
Outline on rafters of former E-W panel dividing 2nd floor of unit "B" into a north and a south room.
